**Flood Control Project Maintenance  
Levee Inspections**  
**LMA District Cover Sheet**  
**Spring 2019 Levee Inspection Results**

**Sutter Maintenance Yard Tisdale Bypass**

**Spring 2019 Levee Inspection Results**

**Levee Inspection Report By Mile - Spring 2019**

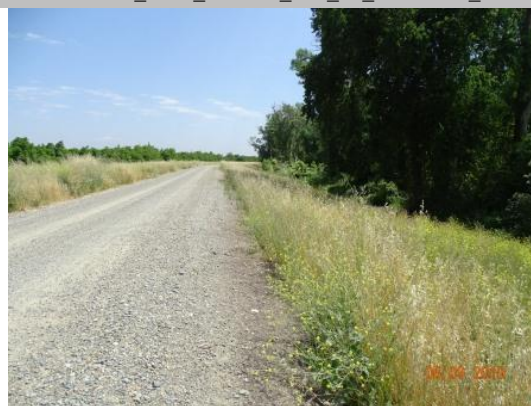
Photo 1 of 1 : SP\_2019\_ST0009\_286\_14\_20190510\_00019.jpg

LM Start	0.02	Rating **	U	Issue No.	14
LM End	4.50	Issue Type +	Ma	Location *	WS
Category	Earthen Levee			GPS Latitude/Longitude	
				Start	End
Item	Vegetation			39.027150 °	39.032827 °
				-121.821447 °	-121.743098 °
DWR ID	DWR_ST0009_01_s_2017_14				
Comment Code					
V1 : Control annual grass and weeds on the levee slopes and easements.					
Inspector Comment

View of the vegetation on the waterside slope. Spring 2019.

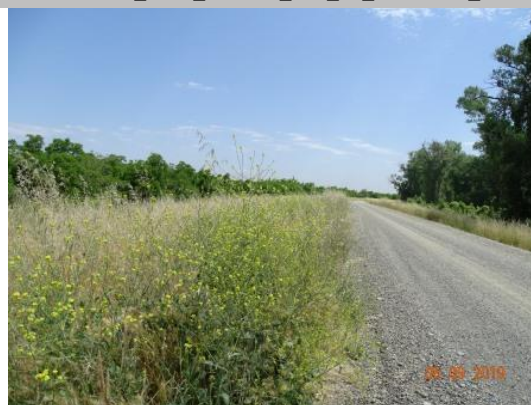
Photo 1 of 1 : SP\_2019\_ST0009\_286\_13\_20190510\_00020.jpg

LM Start	0.02	Rating **	U	Issue No.	13
LM End	4.50	Issue Type +	Ma	Location *	LS
Category	Earthen Levee			GPS Latitude/Longitude	
				Start	End
Item	Vegetation			39.027150 °	39.032895 °
				-121.821447 °	-121.743027 °
DWR ID	DWR_ST0009_01_s_2017_13				
Comment Code					
V1 : Control annual grass and weeds on the levee slopes and easements.					
Inspector Comment

View of the vegetation on the landside slope. Spring 2019.

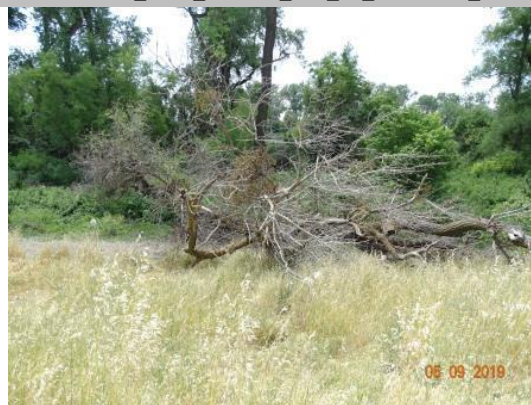
Photo 1 of 1 : SP\_2019\_ST0009\_286\_10\_20190510\_00021.jpg

LM Start	0.77	Rating **	U	Issue No.	10
LM End	0.77	Issue Type +	Ma	Location *	WS
Category	Earthen Levee			GPS Latitude/Longitude	
				Start	End
Item	Encroachments			39.028328 °	39.028328 °
				-121.807756 °	-121.807756 °
DWR ID	DWR_ST0009_01_s_2019_10				
Comment Code					
TR : Tree or limb					
Inspector Comment					
The large tree should be removed from the waterside slope.

View of a large tree on the waterside slope. Spring 2019.

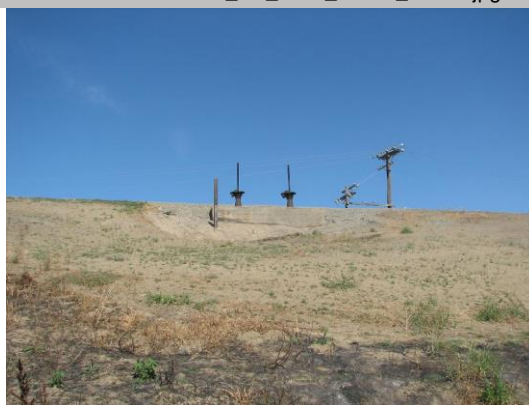
Photo 1 of 3 : UCIP\_SP\_2019\_51484\_64226.jpg

Comment Code					
Inspector Comment					
FS_ID:51484 DS_ID:16591 EP_NO: 10099 Repair Type: No Action Needed Crossing Status: Found UCIP Comments: 4/10/2017 Crossing appears to be in good condition. (DWR Sutter Yard- A Freitag)10/11/2016 Crossing appears to be in good condition.(DWR Sutter Yard - a Freitag)4/18/2016 Crossing appears to be in good condition. No noticeable issues to report.5/7/2015 Crossing is in good condition. No noticeable issues to report.11/13/2014 Same as last inspection.5/12/2014 Same as last inspection.10/30/2013 Same as last inspection.5/20/2013 Same as last inspection. FIELD_STRUCT_DESC: 1 of 2: 4-foot by 7-foot reinforced concrete discharge tunnel through the levee, 38 feet below the crown. Slide gate in 4-foot by 15-foot concrete well on the waterside (WS) slope. Pump house located on the landside (LS) toe and wooden flap gates on the WS toe. (two 4-foot by 7-foot tunnel [HLM 2.13] authorized under Automatic Board Order (ABO) issued as Permit No. 10099, 1955 - Reclamation District No. 1660). [Additional Reference(s): DWR Levee Log, 1993. USACE Sacramento O&M Manual 133, August 1955 (Station 1044+60)]. FS Date: 4/12/2017 9:20:05 AM

Slide gates on WS shoulder.

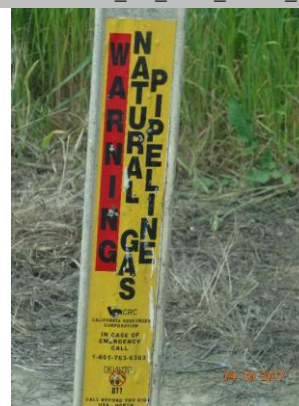
Photo 1 of 2 : UCIP\_SP\_2019\_51486\_76941.jpg

Comment Code						
Inspector Comment						
FS_ID:51486 DS_ID:16590 EP_NO: 14740 Repair Type: Non-Urgent Crossing Status: Indicator Found UCIP Comments: 4/10/2017 Carsonite marker on WS missing. (DWR Sutter Yard- AFreitag)10/11/2016 Carsontie marker on WS shoulder is still missing.(DWR Sutter Yard - afreitag)4/18/2016 Carsonite marker on WS shoulder is missing.5/7/2015 Marker on WS shoulder missing.11/13/2014 Same as last inspection.5/12/2014 Same as last inspection.10/30/2013 Same as last inspection.5/20/2013 Carsonite marker on WS shoulder missing and should be replaced. FIELD_STRUCT_DESC: 4-inch steel gas pipeline through the levee and under channel, 2.5 feet below the crown. Carsonite signs on both the landside (LS) and the waterside (WS) shoulders. Gas wells 200 feet off of the LS toe. (Permit No. 14740, 1988 - Nahama and Weagant Energy Co.) [Additional Reference(s): DWR Levee Log, 1993]. FS Date: 4/12/2017 9:21:13 AM

Close up of LS marker

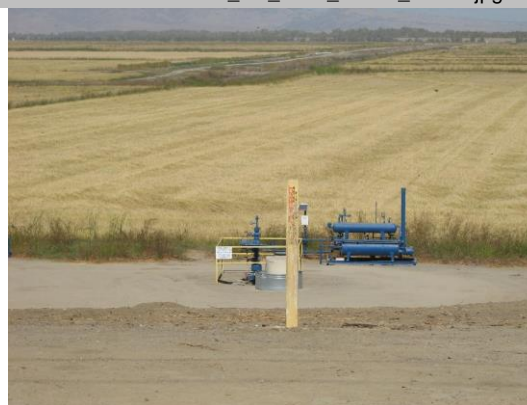
Photo 2 of 2 : UCIP\_SP\_2019\_51486\_64220.jpg

Carsonite sign on LS shoulder with view of gas well in background.

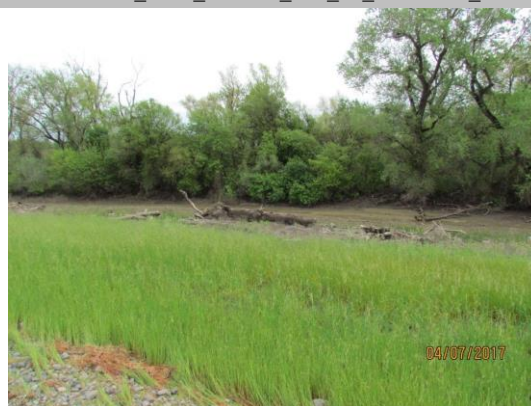
Photo 1 of 1 : SP\_2019\_ST0009\_286\_24\_20190327\_00004.jpg

View of the debris along the waterside slope and toe.

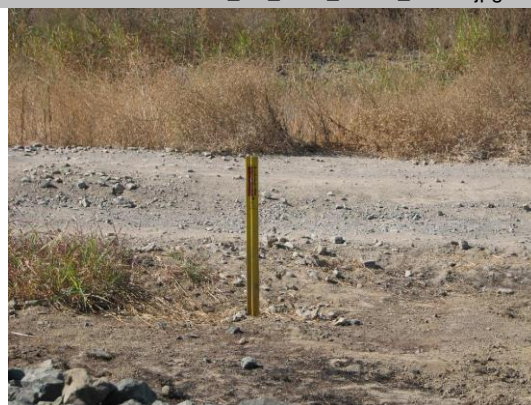
Photo 1 of 3 : UCIP\_SP\_2019\_51487\_64235.jpg

Comment Code					
Inspector Comment					
FS_ID:51487 DS_ID:16855 EP_NO: 14455 Repair Type: Non-Urgent Crossing Status: Indicator Found UCIP Comments: 4/10/2017 LS marker still broken and there is no marker on the WS. (DWR Sutter Yard- AFreitag)10/11/2016 LS carsonite marker is still broken.(DWR Sutter Yard - afreitag)4/18/2016 Carsonite marker on LS slope is broke off.5/7/2015 Crossing is in good condition. No noticeable issues to report.11/13/2014 Same as last inspection.5/12/2014 Same as last inspection.10/30/2013 Same as last inspection.5/20/2013 Same as last inspection. FIELD_STRUCT_DESC: 1 of 2: 4.5-inch steel natural gas pipeline through the levee, 2 feet below the crown. Line goes across the Sutter Bypass and through both levees. Carsonite sign on the landside (LS) slope. Drawings are available. (Permit No. 14455, 1986 - Depco Inc.). [Additional Reference(s): DWR Levee Log, 1993]. FS Date: 4/12/2017 9:22:54 AM

Carsonite sign on LS slope.

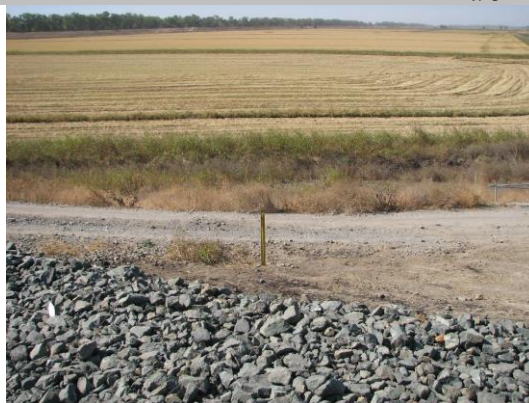
Photo 2 of 3 : UCIP\_SP\_2019\_51487\_64234.jpg

Comment Code						
Inspector Comment						
FS_ID:51487 DS_ID:16855 EP_NO: 14455 Repair Type: Non-Urgent Crossing Status: Indicator Found UCIP Comments: 4/10/2017 LS marker still broken and there is no marker on the WS. (DWR Sutter Yard- A Freitag)10/11/2016 LS carsonite marker is still broken.(DWR Sutter Yard - a Freitag)4/18/2016 Carsonite marker on LS slope is broke off.5/7/2015 Crossing is in good condition. No noticeable issues to report.11/13/2014 Same as last inspection.5/12/2014 Same as last inspection.10/30/2013 Same as last inspection.5/20/2013 Same as last inspection. FIELD_STRUCT_DESC: 1 of 2: 4.5-inch steel natural gas pipeline through the levee, 2 feet below the crown. Line goes across the Sutter Bypass and through both levees. Carsonite sign on the landside (LS) slope. Drawings are available. (Permit No. 14455, 1986 - Depco Inc.). [Additional Reference(s): DWR Levee Log, 1993]. FS Date: 4/12/2017 9:22:54 AM

Carsonite sign on LS slope.

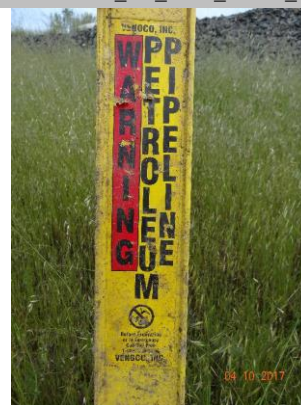
Photo 3 of 3 : UCIP\_SP\_2019\_51487\_76942.jpg

Close up of LS marker

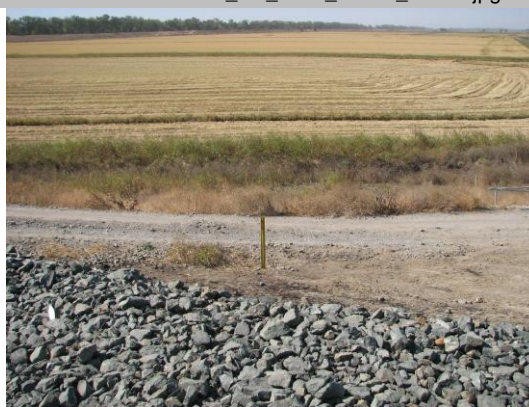
Photo 2 of 3 : UCIP\_SP\_2019\_51488\_64232.jpg

Comment Code						
Inspector Comment						
FS_ID:51488 DS_ID:16589 EP_NO: 14455 Repair Type: Non-Urgent Crossing Status: Indicator Found UCIP Comments: 4/10/2017 LS marker still broken and there is no marker on the WS. (DWR Sutter Yard- AFreitag)10/11/2016 Carsonite marker on the LS is still broken.(DWR Sutter Yard - afreitag)4/18/2016 Carsonite marker on LS slope is broken off.5/7/2015 Crossing is in good condition. No noticeable issues to report.11/13/2014 Same as last inspection.5/12/2014 Same as last inspection.10/30/2013 Same as last inspection.5/20/2013 Same as last inspection. FIELD_STRUCT_DESC: 2 of 2: 4.5-inch steel natural gas pipeline through the levee, 2 feet below the crown. Line goes across the Sutter Bypass and through both levees. Carsonite sign located on the landside (LS) slope. (Permit No. 14455, 1986 - Depco Inc.). [Additional Reference(s): DWR Levee Log, 1993]. FS Date: 4/12/2017 9:24:35 AM

Carsonite sign on LS slope.

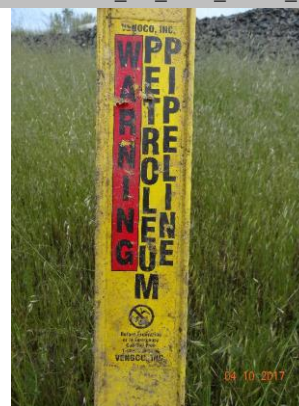
Photo 3 of 3 : UCIP\_SP\_2019\_51488\_76943.jpg

Comment Code						
Inspector Comment						
FS_ID:51488 DS_ID:16589 EP_NO: 14455 Repair Type: Non-Urgent Crossing Status: Indicator Found UCIP Comments: 4/10/2017 LS marker still broken and there is no marker on the WS. (DWR Sutter Yard- AFreitag)10/11/2016 Carsonite marker on the LS is still broken.(DWR Sutter Yard - afreitag)4/18/2016 Carsonite marker on LS slope is broken off.5/7/2015 Crossing is in good condition. No noticeable issues to report.11/13/2014 Same as last inspection.5/12/2014 Same as last inspection.10/30/2013 Same as last inspection.5/20/2013 Same as last inspection. FIELD_STRUCT_DESC: 2 of 2: 4.5-inch steel natural gas pipeline through the levee, 2 feet below the crown. Line goes across the Sutter Bypass and through both levees. Carsonite sign located on the landside (LS) slope. (Permit No. 14455, 1986 - Depco Inc.). [Additional Reference(s): DWR Levee Log, 1993]. FS Date: 4/12/2017 9:24:35 AM

Close up of LS marker

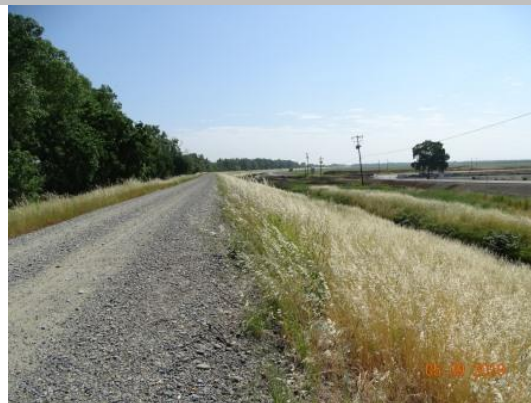
Photo 1 of 1 : SP\_2019\_ST0009\_287\_15\_20190510\_00018.jpg

View of the vegetation on the landside slope. Spring 2019.

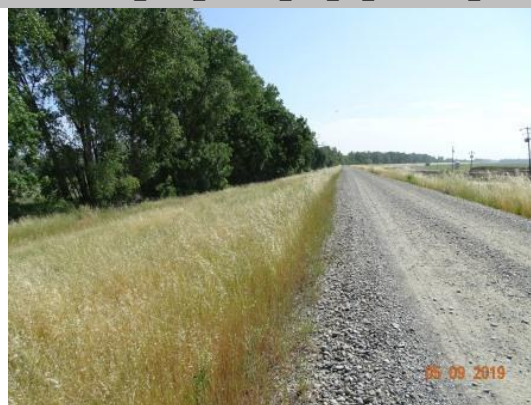
Photo 1 of 1 : SP\_2019\_ST0009\_287\_16\_20190510\_00017.jpg

LM Start	0.00	Rating **	U	Issue No.	16
LM End	4.41	Issue Type +	Ma	Location *	WS
Category	Earthen Levee			GPS Latitude/Longitude	
				Start	End
Item	Vegetation			39.023232 °	39.021637 °
				-121.820730 °	-121.741315 °
DWR ID	DWR_ST0009_02_s_2017_16				
Comment Code					
V1 : Control annual grass and weeds on the levee slopes and easements.					
Inspector Comment

View of the vegetation on the waterside slope. Spring 2019.

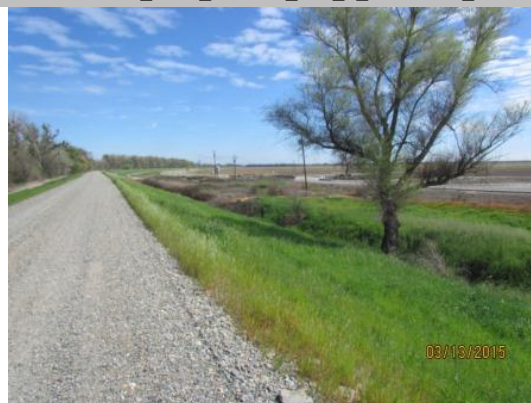
Photo 1 of 1 : SP\_2019\_ST0009\_287\_1\_20190327\_00001.jpg

LM Start	0.11	Rating **	M	Issue No.	1
LM End	0.26	Issue Type +	En	Location *	LS
Category	Earthen Levee			GPS Latitude/Longitude	
				Start	End
Item	Encroachments			39.023760 °	39.024559 °
				-121.818875 °	-121.816344 °
DWR ID	DWR_ST0009_02_s_2012_1				
Comment Code					
DT : Ditch					
Inspector Comment

View of the agricultural ditch along the landside toe.

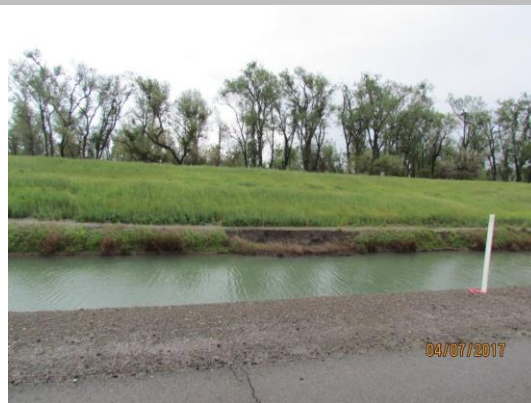
Photo 1 of 1 : SP\_2019\_ST0009\_287\_9\_20190327\_00005.jpg

LM Start	0.69	Rating **	M	Issue No.	9
LM End	0.71	Issue Type +	Ma	Location *	LS
Category	Earthen Levee			GPS Latitude/Longitude	
				Start	End
Item	Erosion / Bank Caving			39.025602 °	39.025657 °
				-121.808527 °	-121.808027 °
DWR ID	DWR_ST0009_02_s_2017_9				
Comment Code					
E2 : Schedule repair of erosion site prior to the next inspection.					
Inspector Comment

View of the erosion along the landside toe from the County Road.

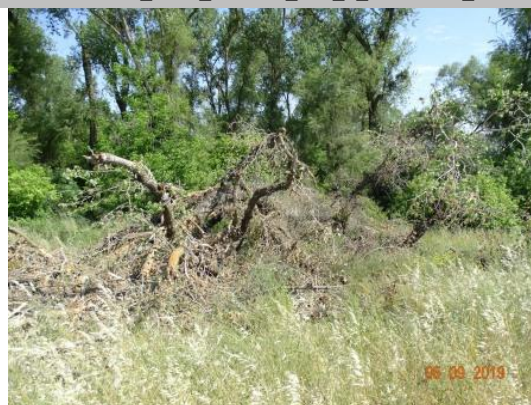
Photo 1 of 1 : SP\_2019\_ST0009\_287\_7\_20190510\_00019.jpg

LM Start	0.92	Rating **	U	Issue No.	7
LM End	0.92	Issue Type +	Ma	Location *	WS
Category	Earthen Levee			GPS Latitude/Longitude	
				Start	End
Item	Encroachments			39.025536 °	39.025536 °
				-121.804139 °	-121.804139 °
DWR ID	DWR_ST0009_02_s_2019_7				
Comment Code					
TR : Tree or limb					
Inspector Comment					
The large tree should be removed from the waterside slope.

View of a large tree on the waterside slope. Spring 2019.

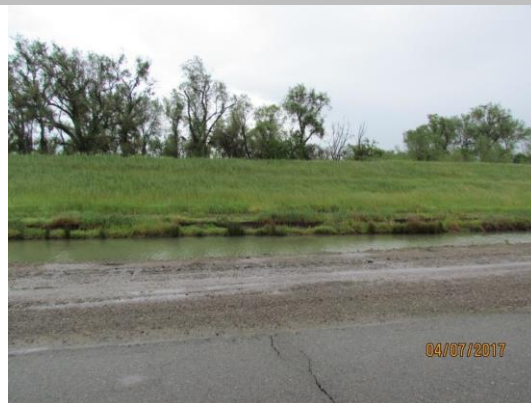
Photo 1 of 1 : SP\_2019\_ST0009\_287\_10\_20190327\_00006.jpg

LM Start	0.97	Rating **	M	Issue No.	10
LM End	0.98	Issue Type +	Ma	Location *	LS
Category	Earthen Levee			GPS Latitude/Longitude	
				Start	End
Item	Erosion / Bank Caving			39.025540 °	39.025572 °
				-121.803272 °	-121.802990 °
DWR ID	DWR_ST0009_02_s_2017_10				
Comment Code					
E2 : Schedule repair of erosion site prior to the next inspection.					
Inspector Comment

View of the erosion along the landside toe from the County Road.

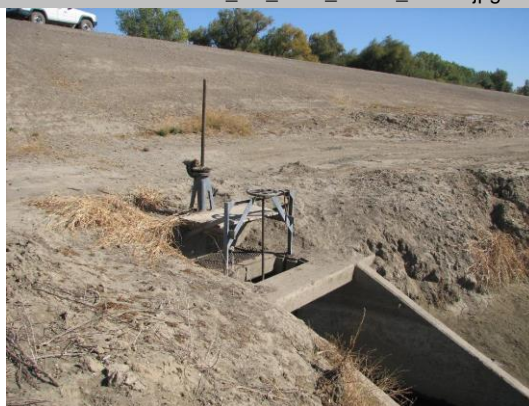
Photo 1 of 3 : UCIP\_SP\_2019\_53047\_64675.jpg

FS\_ID:53047  
DS\_ID:16594  
EP\_NO: 267  
Repair Type: Urgent  
Crossing Status: Found  
UCIP Comments: 10/4/2018 Erosion around WS vault is progressing. Recommended FSRP evaluation of this site. Dense vegetation around the site. Crossing remains "Urgent" due to the erosion observed on WS. (O.Yakimov - DWR)4/10/2017 Erosion appears to be getting worse at the WS vault. It is starting to erode away the WS toe road. (DWR Sutter Yard- A Freitag)10/11/2016 Erosion still present behind the WS vault.(DWR Sutter Yard - a Freitag)4/18/2016 Erosion happening around the WS concrete vault.5/7/2015 Burrowing near WS toe stil present.11/13/2014 Same as last inspection.5/12/2014 Same as last inspection.10/30/2013 Same as last inspection.5/20/2013 Same as last inspection.10/17/2012 Burrowing along downstream side of concrete vault on WS Toe. May need to be grouted.  
FIELD\_STRUCT\_DESC: 54-inch reinforced concrete irrigation pipe through the levee, 29.5 feet below the crown. Slide gates on both the waterside (WS) and the landside (LS) ends. WS end gate in 5-foot by 6-foot concrete box. LS end gate in concrete "U" shaped headwall. Concrete encased steel siphon pipe under and across bypass. (Permit Nos. 267 and 290 - Sutter Basin Improvement Co. [dates unknown]).

Slide gate at concrete outlet on LS toe.

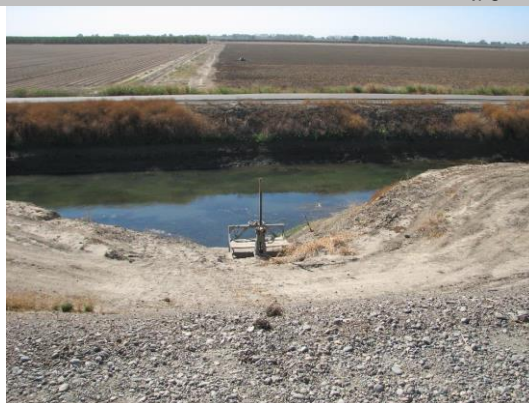
Photo 2 of 3 : UCIP\_SP\_2019\_53047\_64674.jpg

Slide gate at concrete outlet on LS toe.

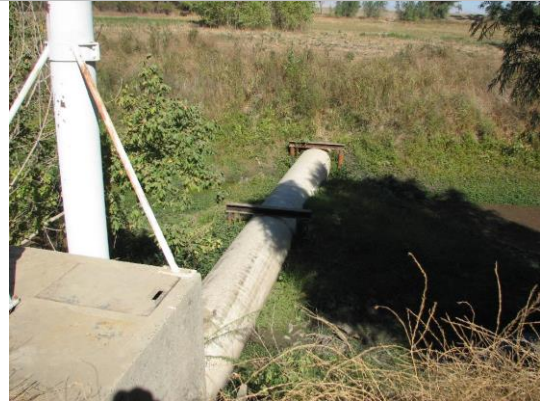
Photo 3 of 3 : UCIP\_SP\_2019\_53047\_64673.jpg

Comment Code						
Inspector Comment						
FS_ID:53047 DS_ID:16594 EP_NO: 267 Repair Type: Urgent Crossing Status: Found UCIP Comments: 10/4/2018 Erosion around WS vault is progressing. Recommended FSRP evaluation of this site. Dense vegetation around the site. Crossing remains "Urgent" due to the erosion observed on WS. (O.Yakimov - DWR)4/10/2017 Erosion appears to be getting worse at the WS vault. It is starting to erode away the WS toe road. (DWR Sutter Yard- AFreitag)10/11/2016 Erosion still present behind the WS vault.(DWR Sutter Yard - afreitag)4/18/2016 Erosion happening around the WS concrete vault.5/7/2015 Burrowing near WS toe stil present.11/13/2014 Same as last inspection.5/12/2014 Same as last inspection.10/30/2013 Same as last inspection.5/20/2013 Same as last inspection.10/17/2012 Burrowing along downstream side of concrete vault on WS Toe. May need to be grouted. FIELD_STRUCT_DESC: 54-inch reinforced concrete irrigation pipe through the levee, 29.5 feet below the crown. Slide gates on both the waterside (WS) and the landside (LS) ends. WS end gate in 5-foot by 6-foot concrete box. LS end gate in concrete ""U"" shaped headwall. Concrete encased steel siphon pipe under and across bypass. (Permit Nos. 267 and 290 - Sutter Basin Improvement Co. [dates unknown]). [Additional Reference(s): DWR Levee Log, 1993. USACE Sacramento O&M Manual 129, August 1955 (Station 61+25)]. FS Date: 10/4/2018 1:10:58 PM

Concrete box, vent, and 54-inch steel pipe in WS toe.

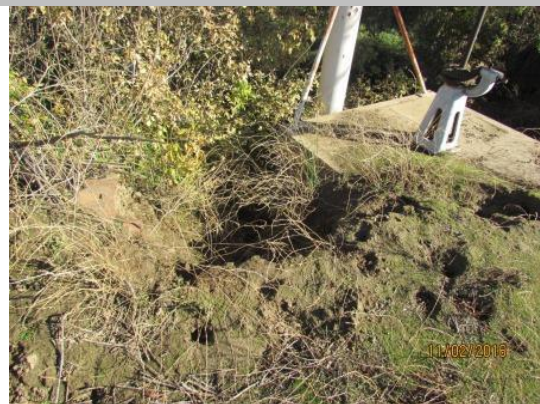
Photo 1 of 2 : SP\_2019\_ST0009\_287\_13\_20190327\_00007.jpg

LM Start	1.14	Rating **	M	Issue No.	13
LM End	1.14	Issue Type +	Ma	Location *	WS
Category	Earthen Levee			GPS Latitude/Longitude	
				Start	End
Item	Erosion / Bank Caving			39.025460 °	39.025460 °
				-121.800022 °	-121.800022 °
DWR ID	DWR_ST0009_02_f_2016_13				
Comment Code					
E2 : Schedule repair of erosion site prior to the next inspection.					
Inspector Comment					
Erosion around the WS concrete vault.

View of the erosion along the concrete vault.

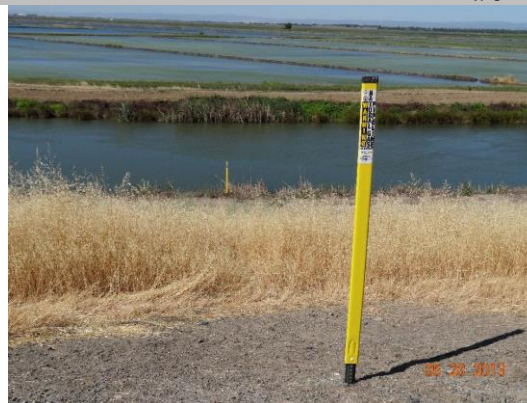
Photo 1 of 3 : UCIP\_SP\_2019\_51491\_64681.jpg

Comment Code					
Inspector Comment					
FS_ID:51491 DS_ID:23099 EP_NO: N/A Repair Type: Non-Urgent Crossing Status: Found UCIP Comments: 4/10/2017 Crossing appears to be in good condition. (DWR Sutter Yard- AFreitag)10/11/2016 Crossing appears to be in good condition but there is no permit on file. Photos of the markers were uploaded on 5/20/2013.(DWR Sutter Yard - afreitag)5/3/2016 Need photos of markers on both WS and LS. 4/18/2016 Crossing appears to be in good condition. No noticeable issues to report.5/7/2015 Crossing is in good condition. No noticeable issues to report.11/13/2014 Same as last inspection.5/12/2014 Same as last inspection.10/30/2013 Same as last inspection.10/17/2012 Need to identify permit for crossing. FIELD_STRUCT_DESC: Steel natural gas pipeline of an unknown size through the levee, at an unknown depth. Markers visible on the landside (LS) shoulder and toe and the waterside (WS) shoulder and toe. No permit has been identified since the crossing was field discovered in 2012. FS Date: 4/12/2017 9:30:05 AM

Marker on LS shoulder and toe

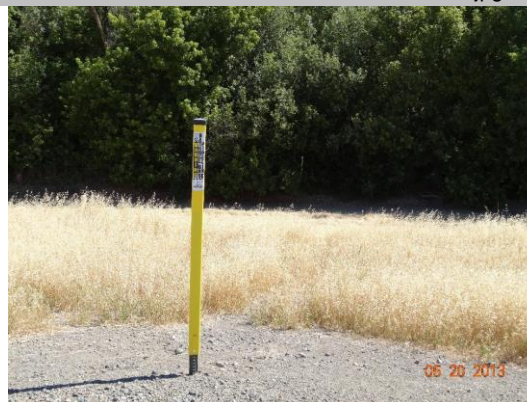
Photo 2 of 3 : UCIP\_SP\_2019\_51491\_64680.jpg

Marker on WS shoulder

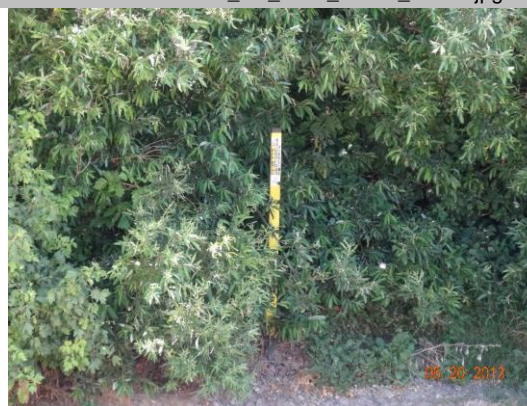
Photo 3 of 3 : UCIP\_SP\_2019\_51491\_64679.jpg

Comment Code						
Inspector Comment						
FS_ID:51491 DS_ID:23099 EP_NO: N/A Repair Type: Non-Urgent Crossing Status: Found UCIP Comments: 4/10/2017 Crossing appears to be in good condition. (DWR Sutter Yard- AFreitag)10/11/2016 Crossing appears to be in good condition but there is no permit on file. Photos of the markers were uploaded on 5/20/2013.(DWR Sutter Yard - afreitag)5/3/2016 Need photos of markers on both WS and LS. 4/18/2016 Crossing appears to be in good condition. No noticeable issues to report.5/7/2015 Crossing is in good condition. No noticeable issues to report.11/13/2014 Same as last inspection.5/12/2014 Same as last inspection.10/30/2013 Same as last inspection.10/17/2012 Need to identify permit for crossing. FIELD_STRUCT_DESC: Steel natural gas pipeline of an unknown size through the levee, at an unknown depth. Markers visible on the landside (LS) shoulder and toe and the waterside (WS) shoulder and toe. No permit has been identified since the crossing was field discovered in 2012. FS Date: 4/12/2017 9:30:05 AM

Marker on WS toe
